REMOVAL ACTION PLAN
FOR
AUTOMATIC INDUSTRIAL PLATING
U.S. EPA ID: PV
TDD: TO5-9112-026
PAN: EIL0763SAA

JANUARY 10, 1992

Re: Automatic Industrial Plating Company, Schaumburg, Illinois
TDD#: T05-9112-026

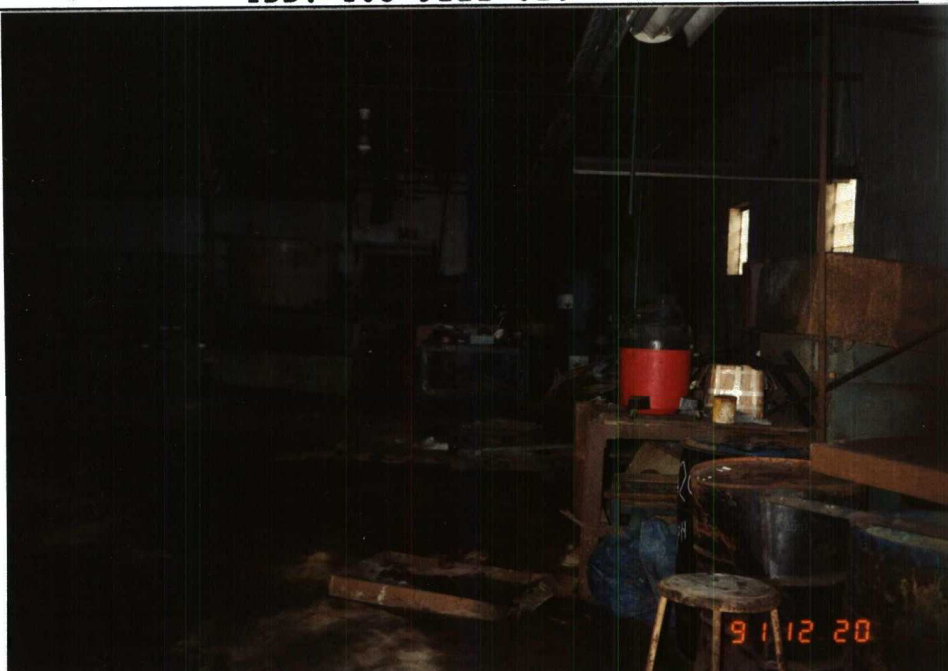
DESCRIPTION: EXISTING SITE CONDITION AS VIEWED FROM INSIDE
OVERHEAD DOOR.

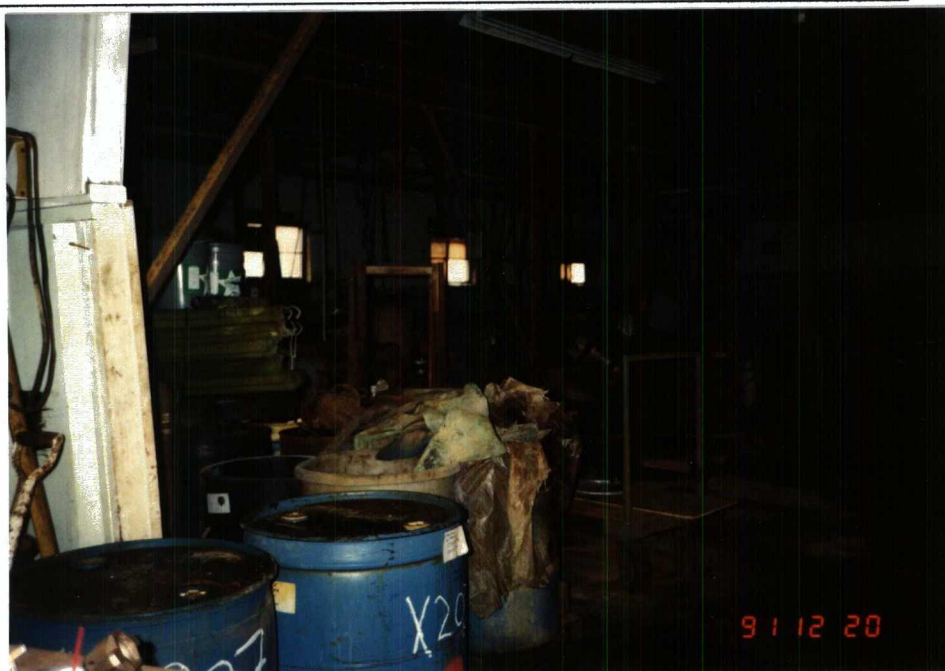
DESCRIPTION: EXISTING SITE CONDITION AS VIEWED FROM INSIDE
OVERHEAD DOOR.

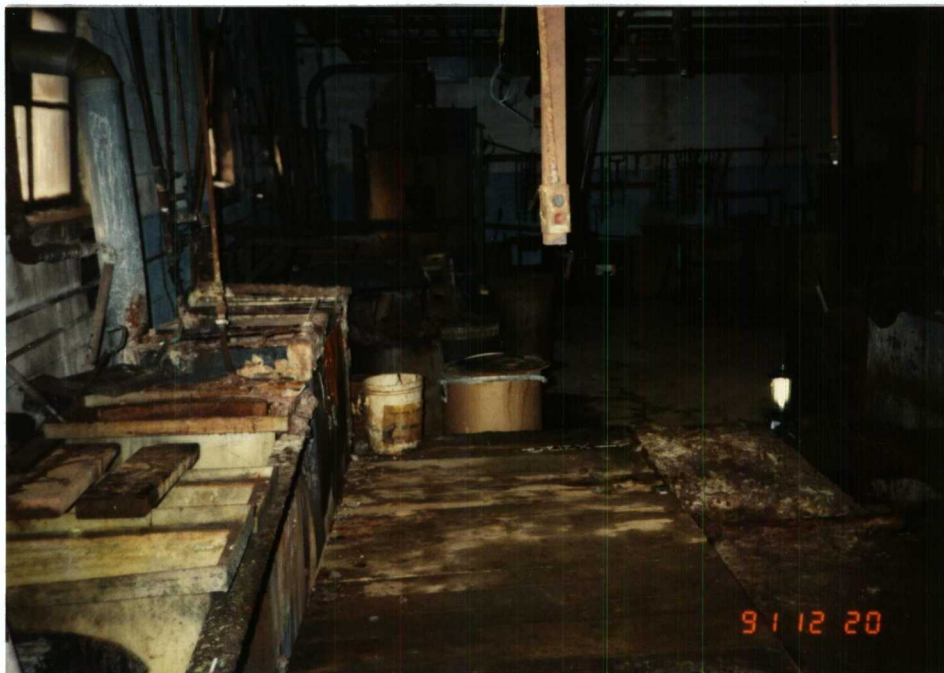
DESCRIPTION: VIEW OF EXISTING PLATING LINE.

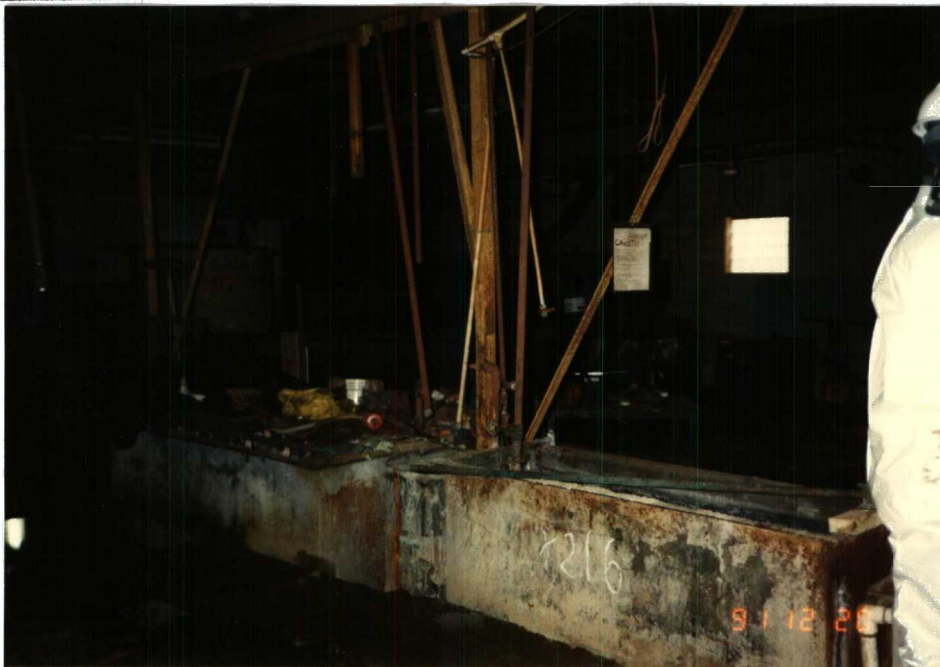
liquid, however, TAT observed significant amounts of white, crystalline solids remaining in the vat. The remaining vats in the east line ranged from 200 to 400 gallons in capacity, and were full of liquid. At the time of the assessment, TAT noted that two of these vats appeared to be made of fiberglass and their contents were frozen and bulging the sides of the vats.

DESCRIPTION: VIEW OF EAST SIDE OF PLATING LINE.

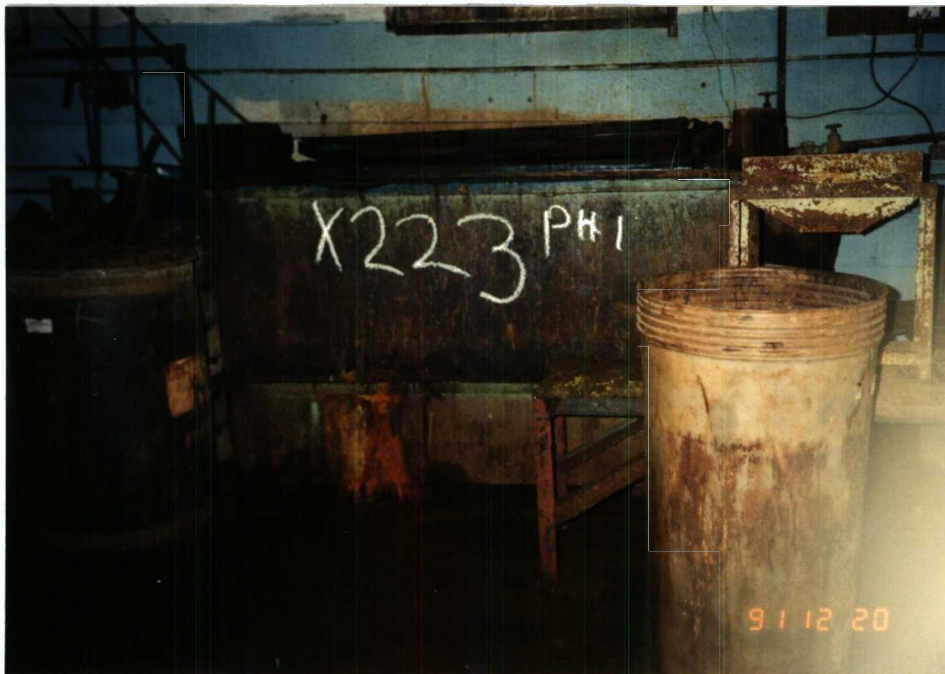
DESCRIPTION: LEAKING VAT WITH LOW pH.

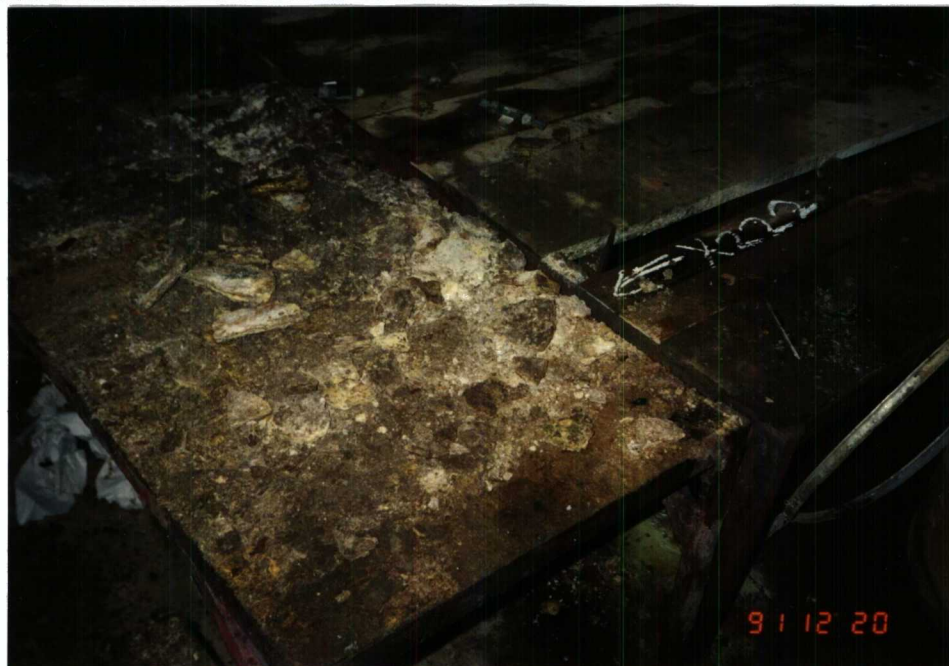
The cat-walk between the plating lines is made of wood and appeared deteriorated, with large holes in the boards of the floor. Several large holes were observed in the roof of the building, and at the time of the assessment TAT observed rain water leaking into the building in the area around the open vats. The concrete floor of the building is deteriorated and approximately 1 inch of sludge was noted on the floor around the vats in the plating operation area. TAT observed a large pool of liquid on the floor near the center of the building which registered a pH of 2 S.U.

DESCRIPTION: DETERIORATED CATWALK IN PLATING LINE WITH PLATING SLUDGES.

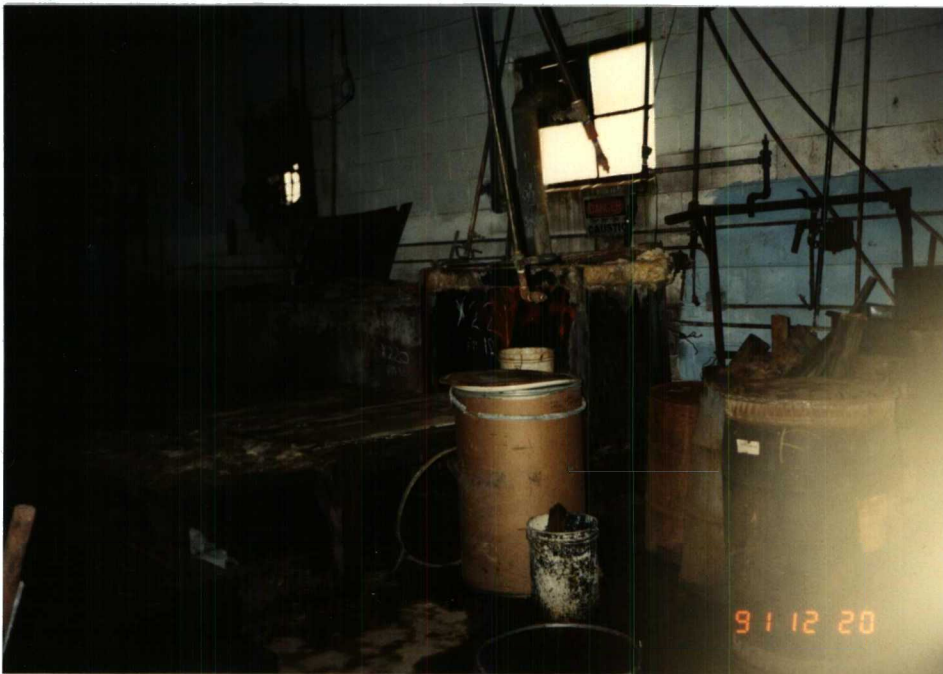
SAMPLE ID
(if applicable):
VS-4

DESCRIPTION: VAT IN PLATING LINE LABELED CAUSTIC.

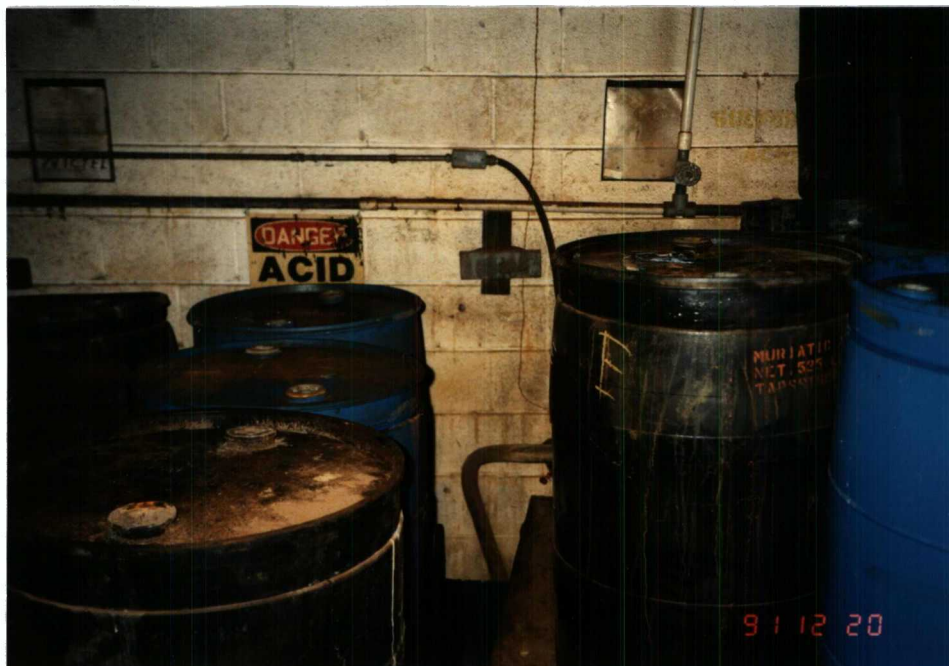
Site investigations by IEPA and TAT contractors have identified that approximately 160 containers, whose contents include chemicals or by-products used in metal plating processes, exist at the Automatic Industrial Plating site. Most of the drums (ranging from 5 to 55 gallons) and vats or tanks (ranging from 100 to 3,000 gallons) were open and unsecured, and of questionable integrity. In addition, analytical data from on-site samples revealed the presence of hazardous materials that could leak from their containers and contaminate their surroundings.

DESCRIPTION: STORED, BULGING DRUMS, LABELED ACIDS.
SLUDGES.

Concurrent with the compatibility testing, ERCS would secure any deteriorated drums or containers into 85-gallon overpack drums. Following compatibility testing and compositing, samples would be sent U.S. EPA-approved disposal facilities for acceptance.
